LAUREL HILL HOUSE

Historic Structure Report and Treatment Options

D. Building Description and Condition Assessment**1. Architectural Description and Condition Assessment****a. Synopsis**

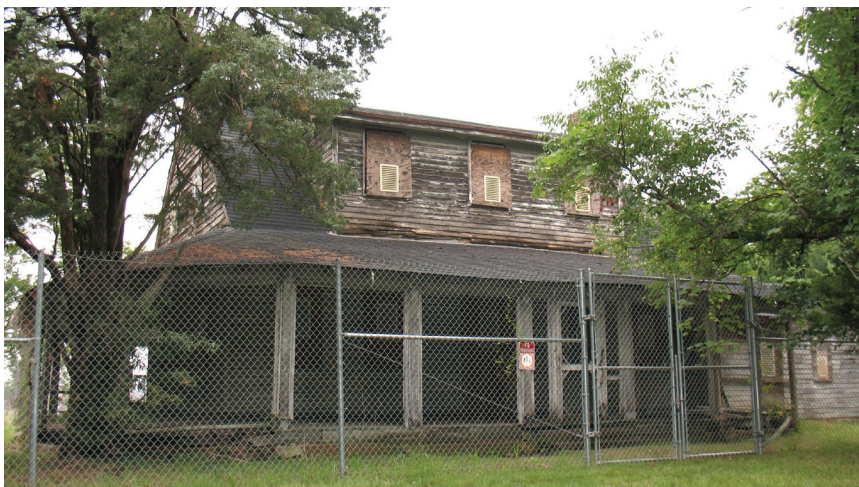
View of front (south) side of building. (X1)

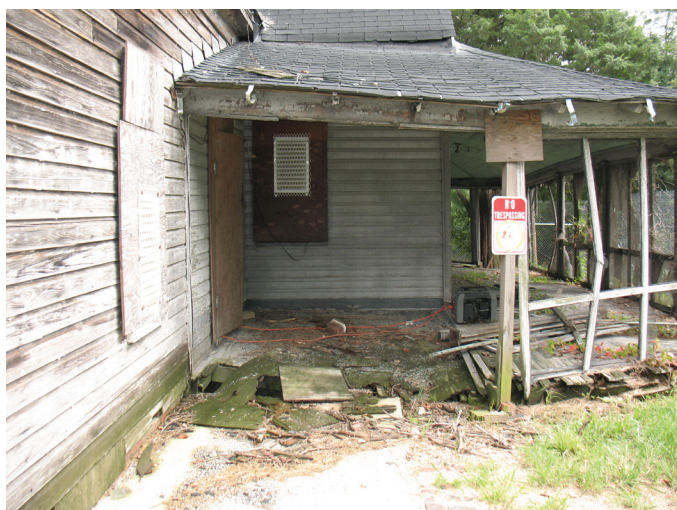
The wraparound porch was added by the time of photos dating to the early-twentieth century. The porch has some interesting details including shaped rafter tails and engaged columns on posts that create a paneled appearance by tracing the porch openings with moldings (Photo X2). The tongue-and-groove floor and its supporting structure are showing severe distress and collapse in some areas (Photos X3, X6 and X15). The beaded tongue-and-groove ceiling boards are similarly in varying states of disrepair (Photo X3). Deflection can be seen in the roof structure above the northwest end of the porch. The entire porch is severely deteriorated, and parts will likely collapse in the near future (Photos X6 and X15).

Detail view of porch on northwest side of the house. (X6)

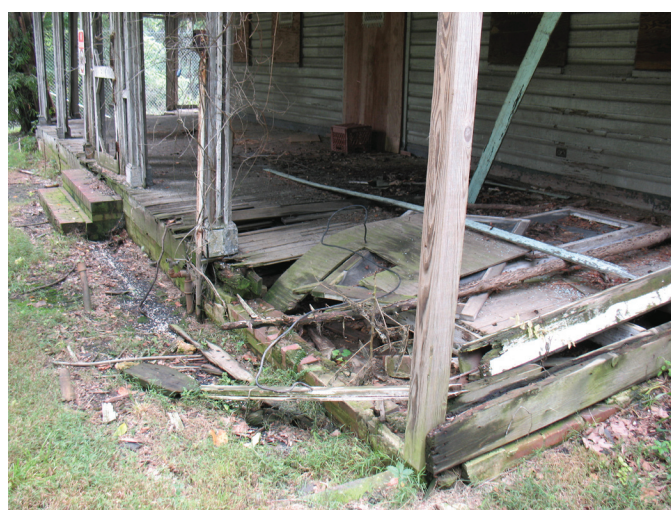
Detail of southeast corner of porch. (X15)

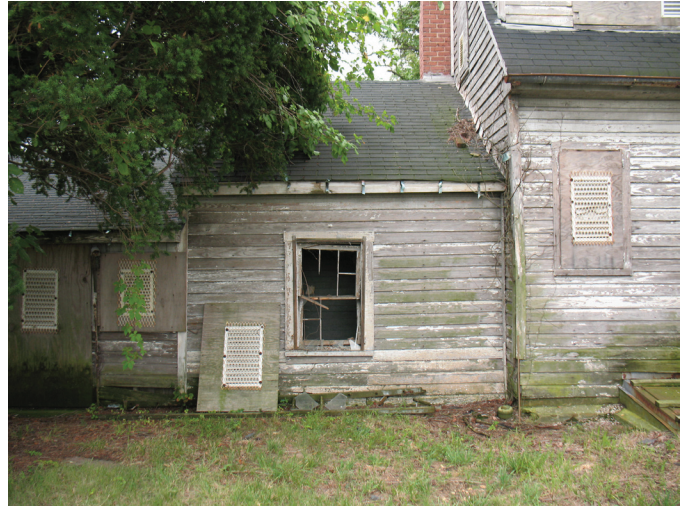
Close-up view of house from north side. (X10)

The windows are typically double-hung wood sash windows with some casements seen in the one-story additions. Few of the original six-over-six sash windows remain. They were replaced with two-over-two windows, possibly at the time the rear addition was added. While the windows are covered with vented plywood, their condition varies from fair to poor (X7, X8, X9, X10 and X12).

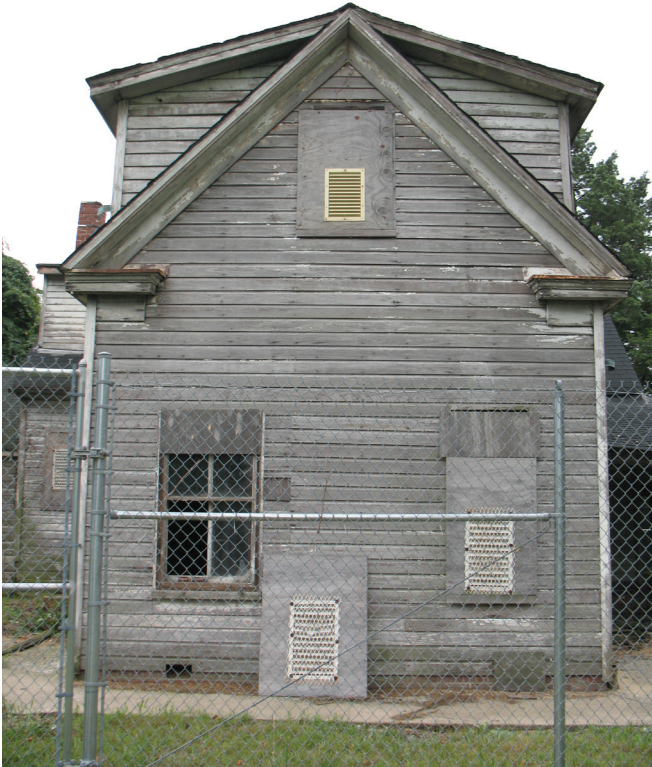
Close-up view of rear addition from north side. Note shed dormers and classical cornice with returns. (X7)

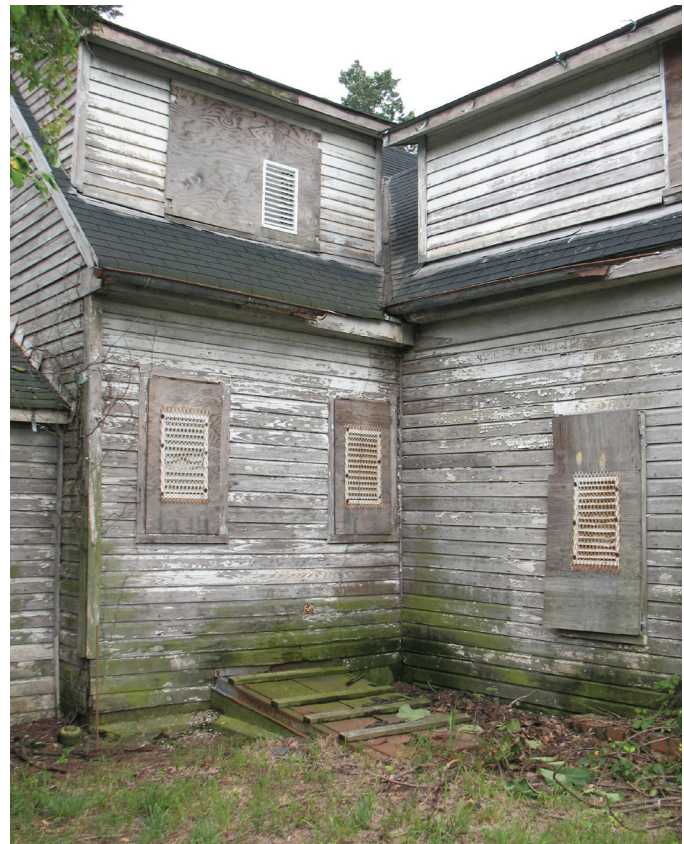
Close-up detail of building from northeast side that shows beveled siding on the dormers and German siding on the wall of the original house and addition. (X9)

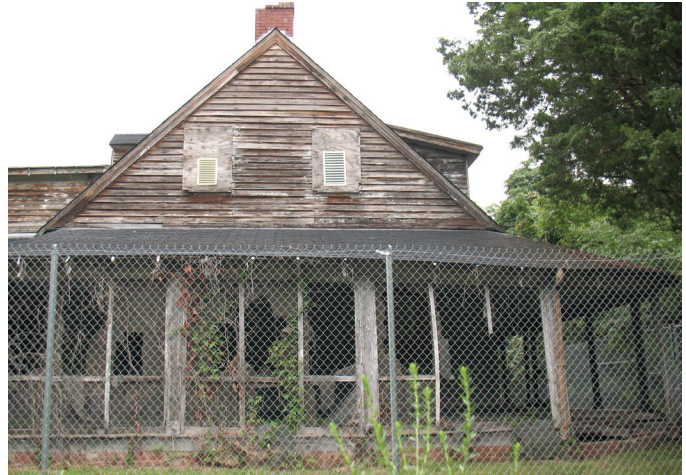
The top of the west chimney has deteriorated. The east chimney is being held together at its top with a metal strap.

View of chimney on the west side of original section of the house. (X4)

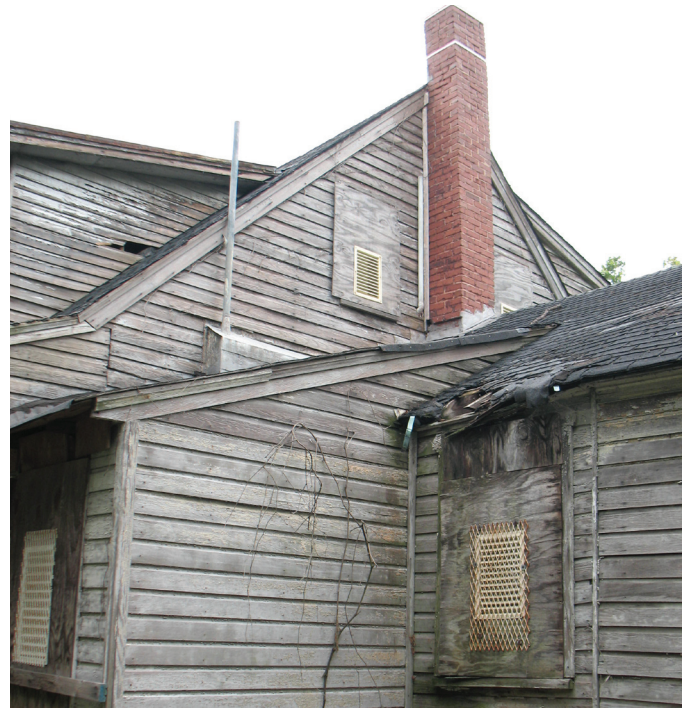
View of chimney on the east side of the original section of the house. (X14)

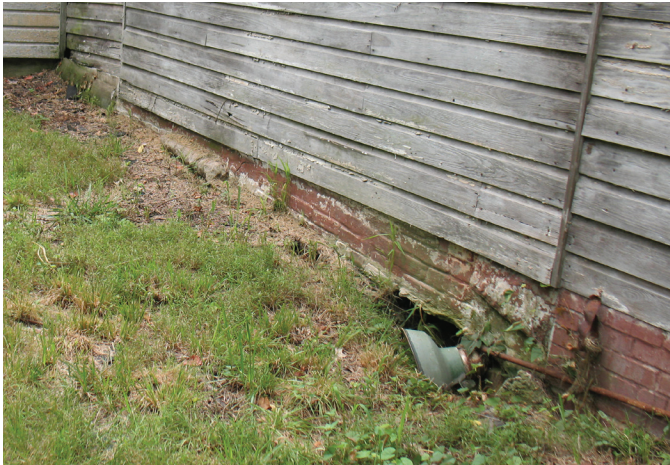
View of hole in foundation on south side of building. (X16)

Several areas of the foundation, along the southeast side of the building, have holes or are partially collapsed (X16).

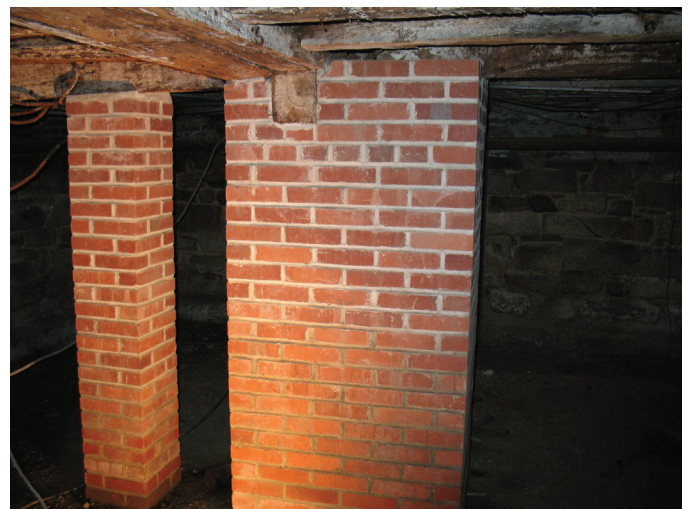
On the east side of the basement, more modern dimensional framing can be seen along with rusty steel girders. Brick piers, that utilize prison-era brick, have been used to supplement or replace the original basement structure (B01-3).

View of supplemental brick piers added in basement. (B01-3)

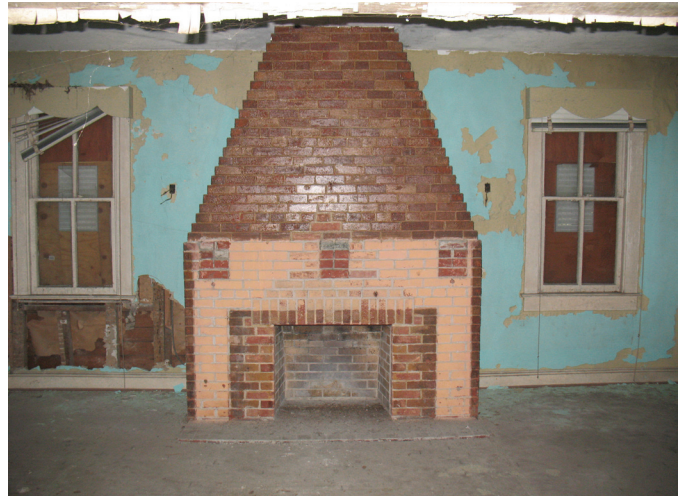
This room was part of the original section of the house and has been heavily altered. Most prominently in this room, the original fireplace has been removed and replaced with a large pyramid-shaped fireplace built of exposed penitentiary-era brick (101-1). A classically designed mantel was reportedly removed from this room and is currently in storage (101-3). A 4" x 4" ceramic tile hearth has replaced the original.

View of fireplace constructed with prison era brick. (101-1)

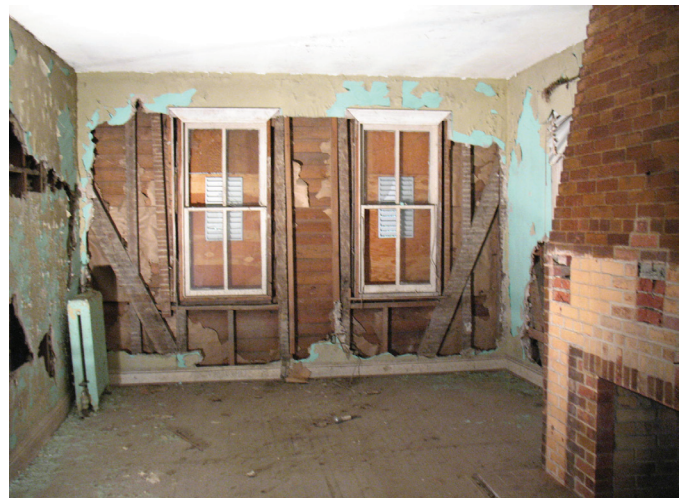
The plaster has been removed on most of the south wall to expose the original braced timber frame (101-2). Insect damage can be seen in this wood framing. Rosin paper is visible between the wood framing and the exterior siding.

View of west wall with braced timber frame exposed. (101-2)

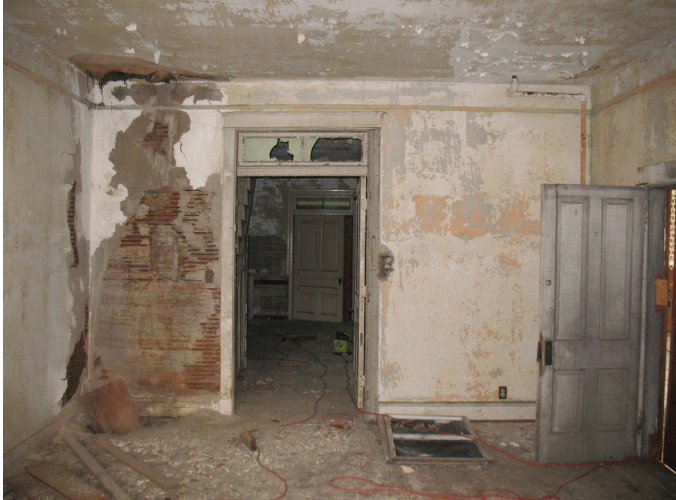
View of rear door to original section of house. Note later wire mesh over German siding at area of water damage to left of door. (102-1)

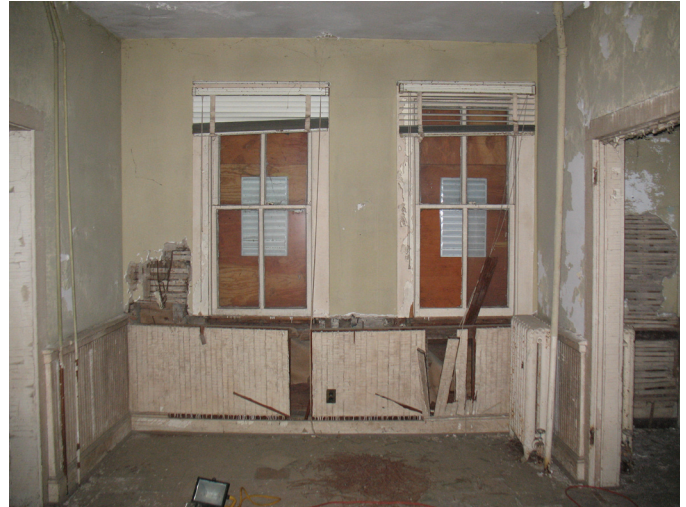
This room was part of the original section (Section 1) of the house and has been heavily altered. The plaster has been applied on wire mesh that is on top of some of the remaining split wood lathe. A tongue-and-groove beaded-wood wainscot with a two-piece base has been added. This wainscot is damaged in several locations (104-1).

View of Room 104 in original section of the house. (104-1)

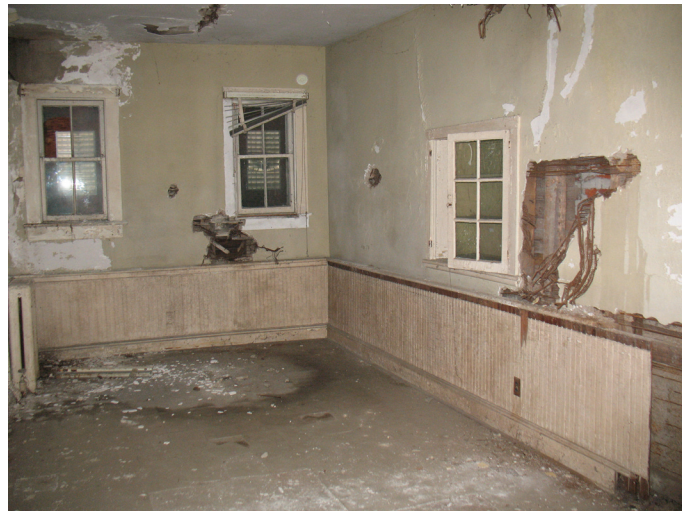
The original window casing has been replaced with painted flat wood casing. The inside of this casing has quarter-round used as window stop. The windows are likely replacements since they have a two-over-two light pattern instead of smaller panes which would have been typical of the original era of construction (104-2).

View of Room 104 in original section of the house. (104-2)

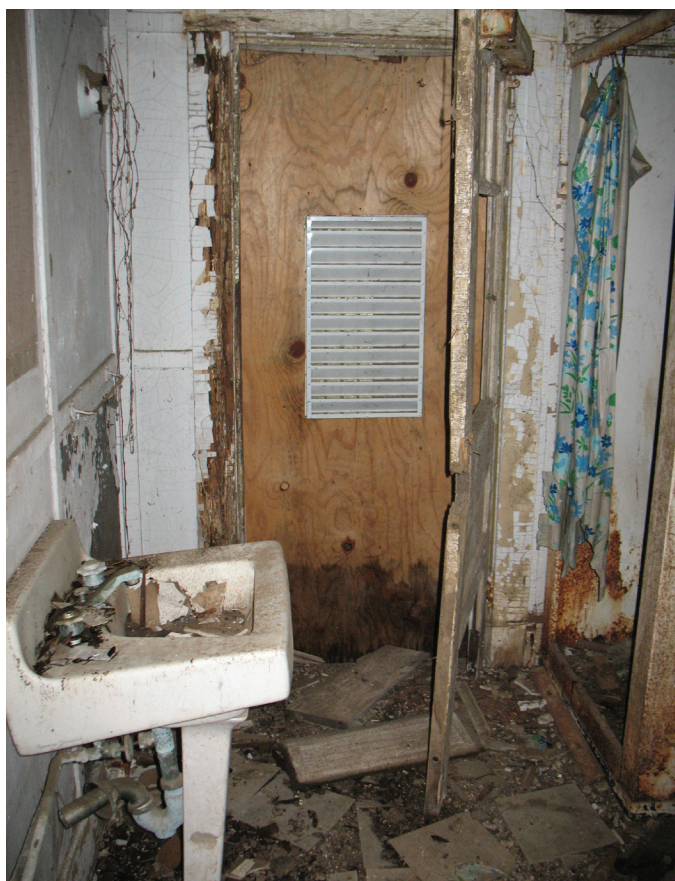
This bathroom is a later addition to the house. It has received considerable damage due to moisture infiltration from the roof and is not safe to enter. The walls are finished with painted hardboard with lattice strips covering the joints. Nothing in the room is capable of being salvaged. Depending on which treatment option is chosen for the building, this room could be considered as a candidate for removal (105-1).

View of Room 105. (105-1)

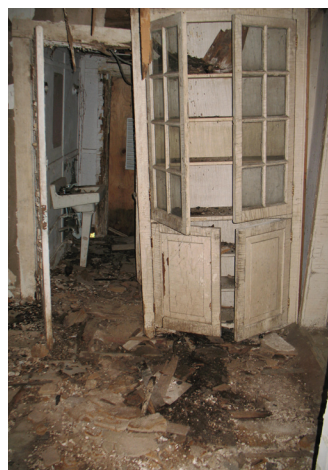
An interesting built-in cabinet in the southwest corner of the room has settled toward the damaged area in the floor (106-1). There is another built-in cabinet, probably dating from the early twentieth century adjacent to the chimney (106-2). This chimney has been boxed in such a way that it is not visible to the room.

View of Room 106 facing bathroom to south. Note water damage to floor and built-in cabinet. (106-1)

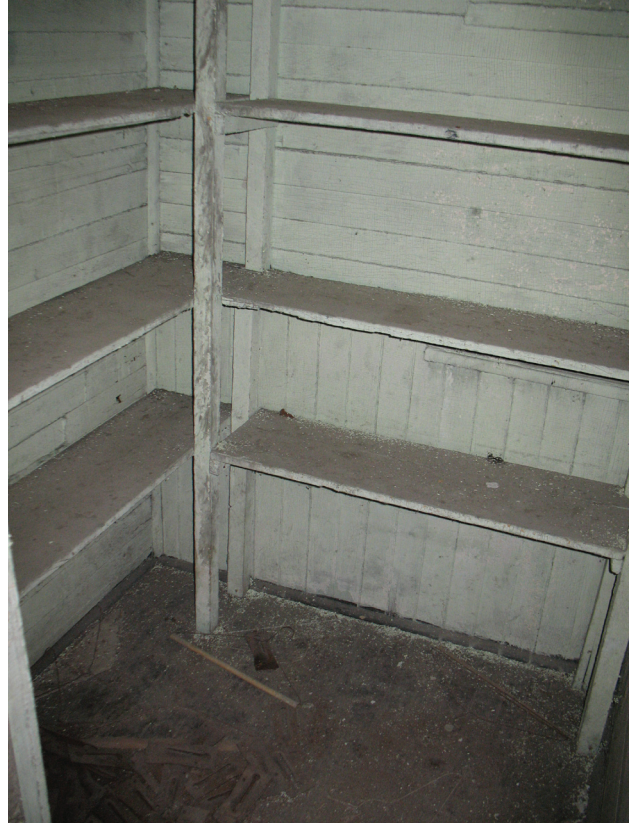
A glass door with ten panes of glass leads into this pantry closet. This room is finished with horizontal and vertical tongue-and-groove boards and is outfitted with painted wood shelving. The overall condition of the room is fair to good (107-1).

View of the interior of the pantry closet, Room 107, adjacent to Room 106. (107-1)

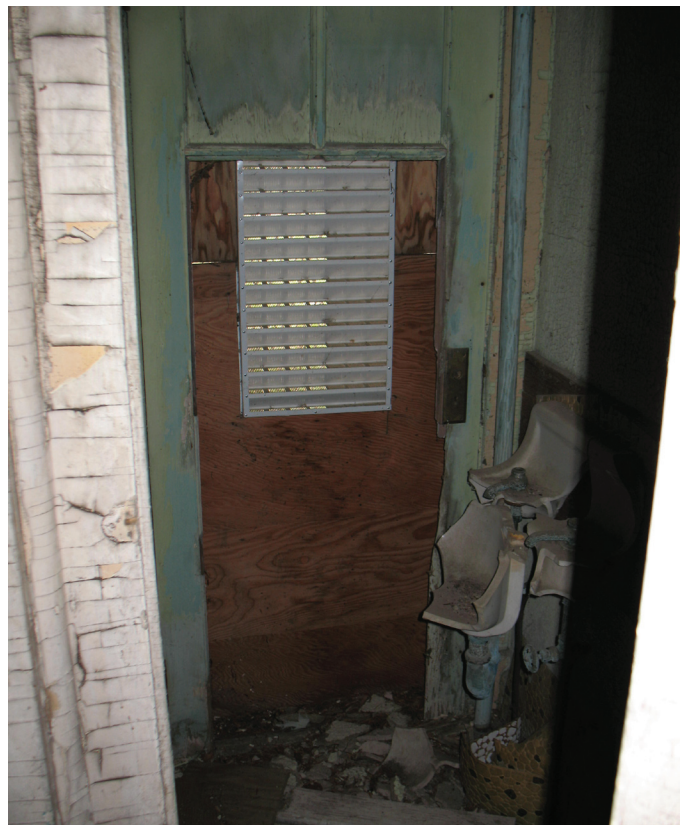
This room and the east end of the kitchen, Room 112, are contained within a shed addition. A fragment of a French door leading to the exterior remains. The plumbing fixtures in this room have been severely damaged and left in place. The windows are six-pane casements with flat casing. The wall finish is painted hardboard with lattice strips covering the joints. The overall condition of the finishes in the room is poor (111-1).

View into room 111 from kitchen. (111-1)

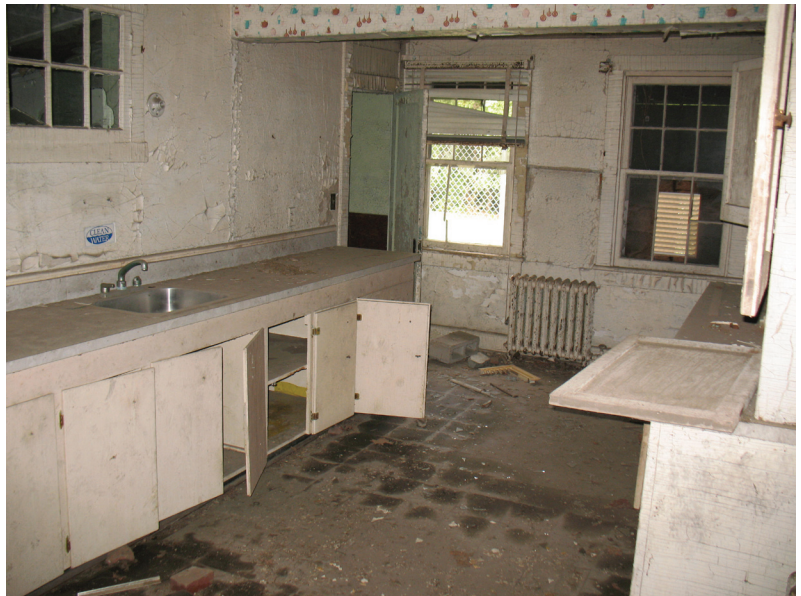
The windows on the east wall have six-over-six light patterns and are heavily damaged. A casement window above the counter top is now leads into the bathroom addition (112-2). The doors are painted stile-and-rail with a variety of panel configurations.

View toward east end of kitchen showing finishes dating from mid-twentieth century. Note casement window on interior wall above countertop. (112-2)
